Situation Photo Log

Monday, March 5, 2012

Kalamazoo River / Enbridge Spill

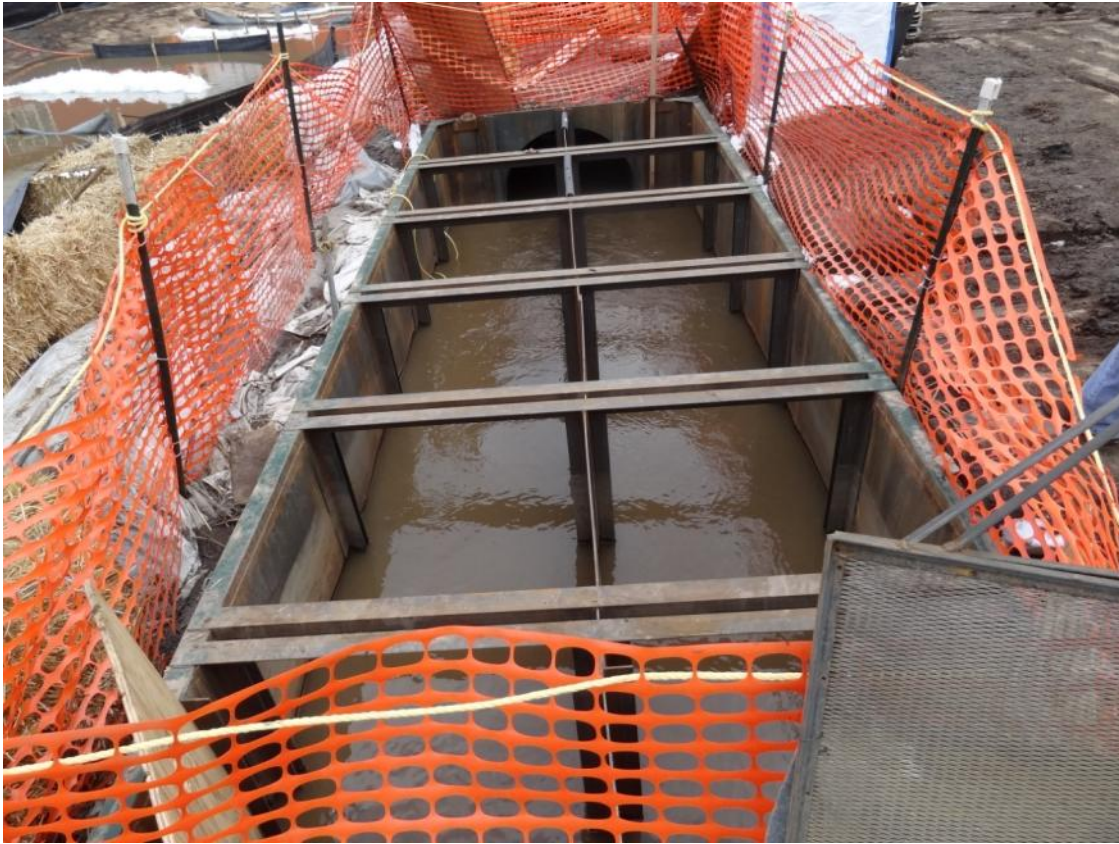
31. Observed filter panels removed from bypass boxes.

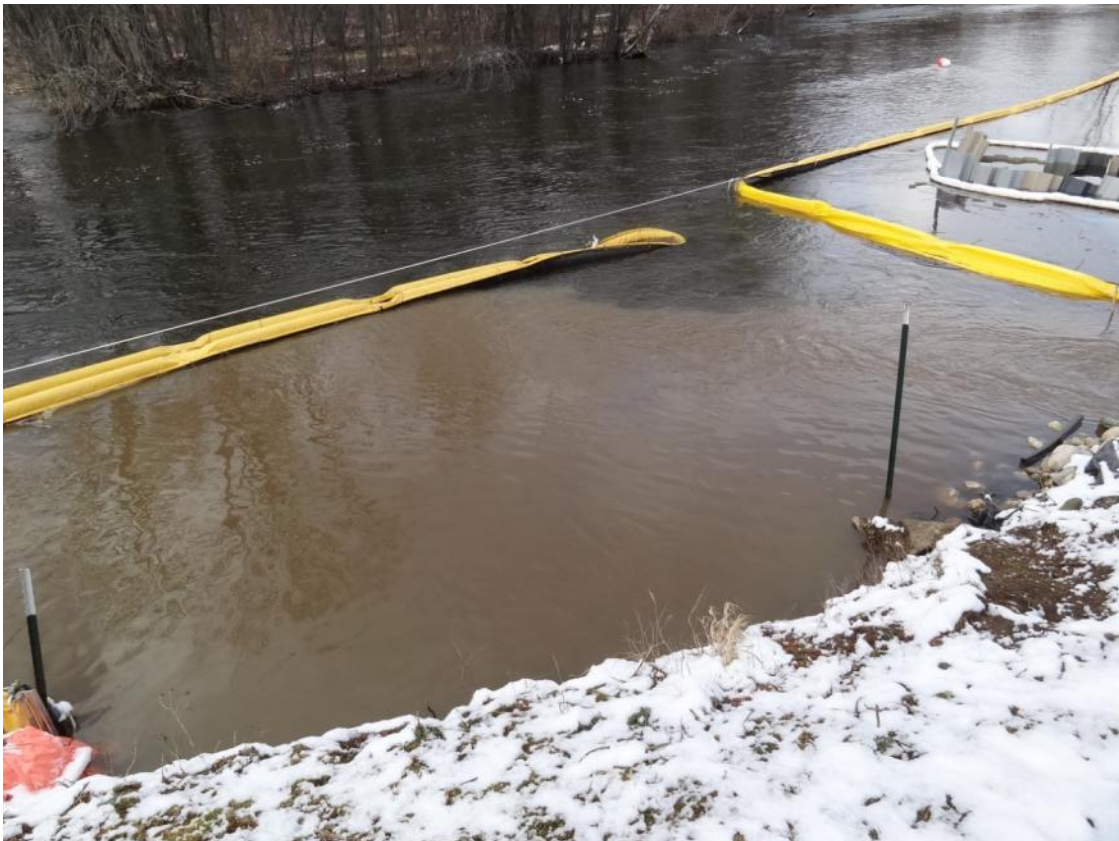
32. Observed turbidity at bypass discharge.

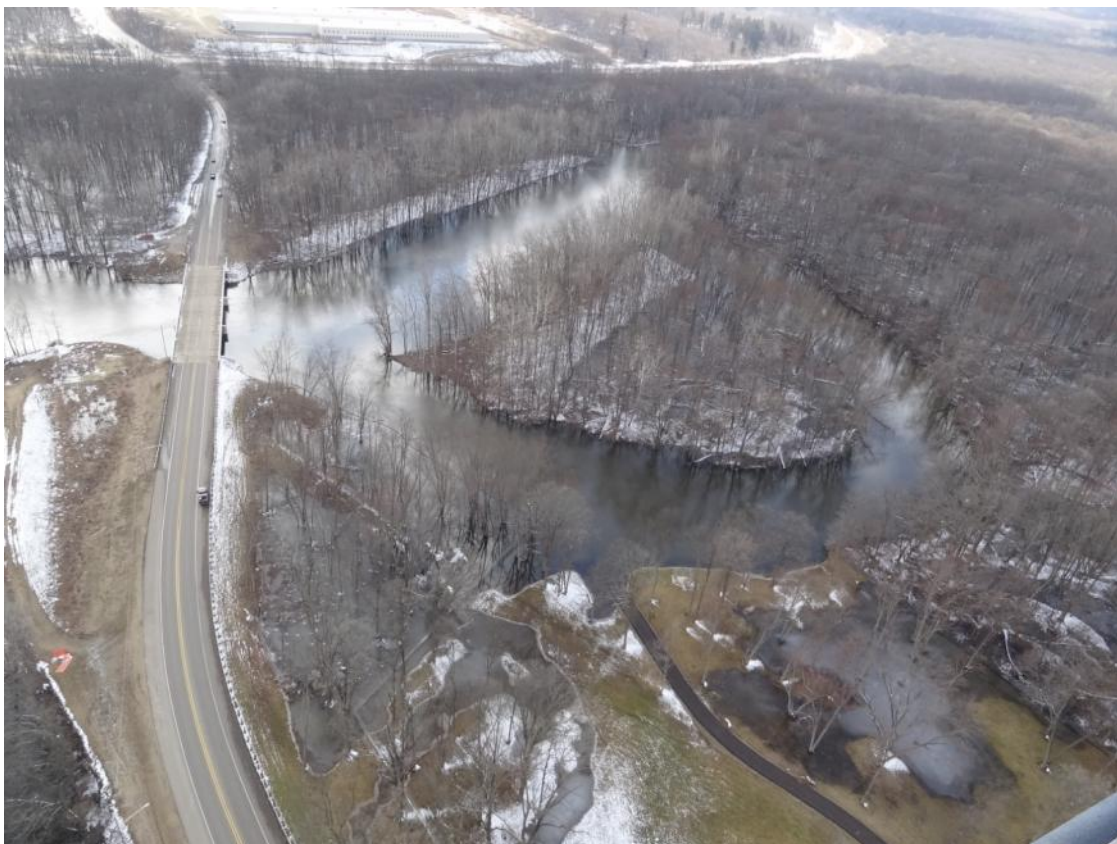
39. MP21.5 Oxbow flooding observed.

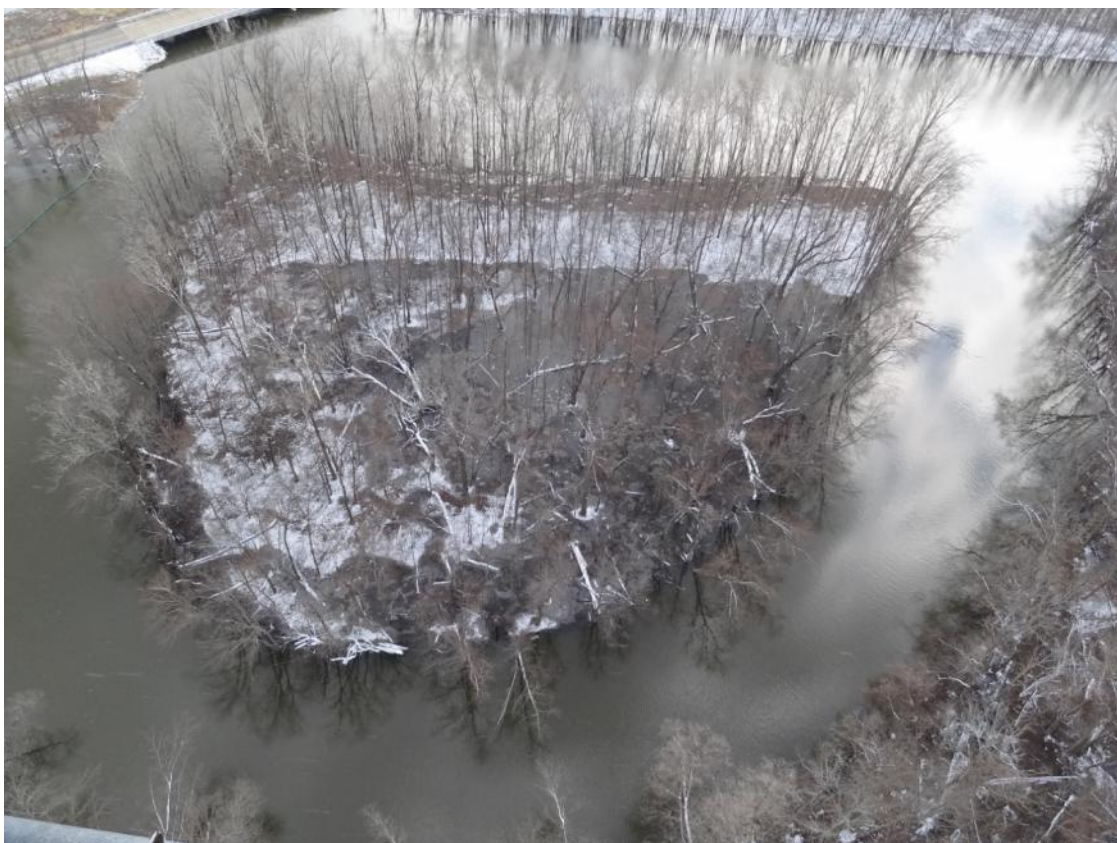
40. MP21.5 Oxbow flooding observed.

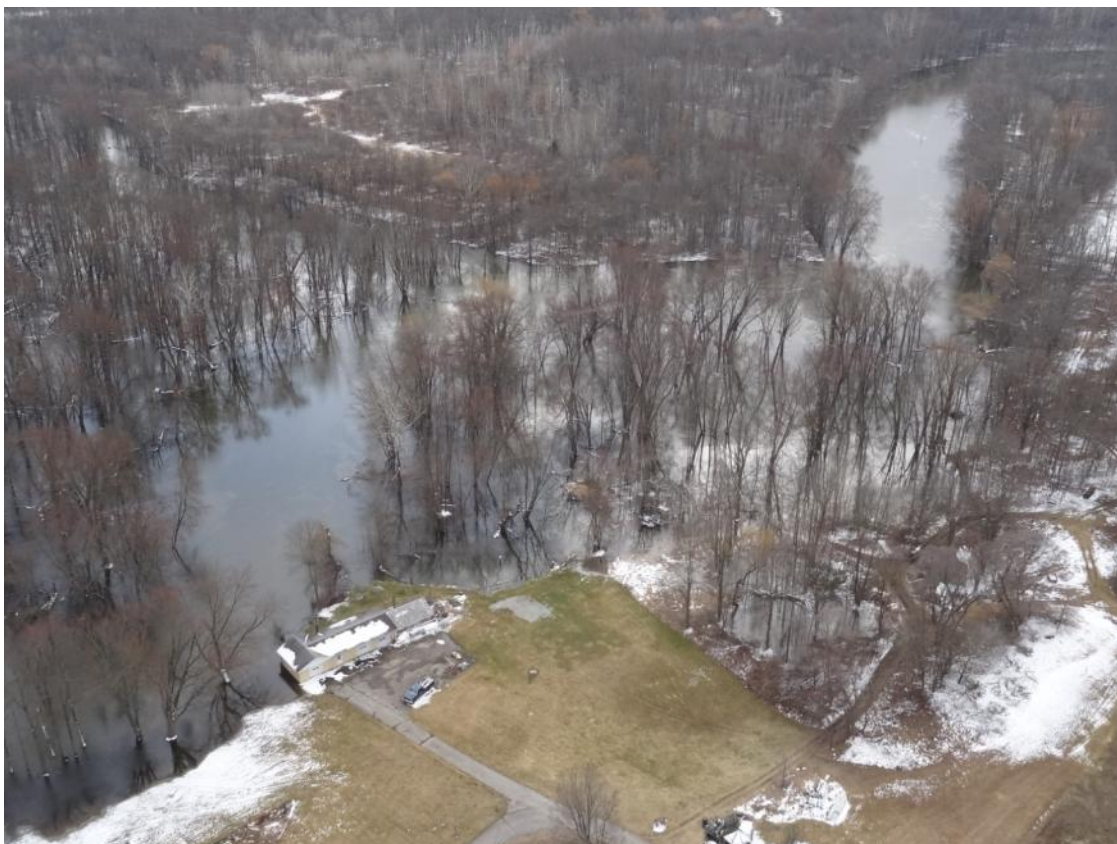
41. Observed flooding at MP26.0.

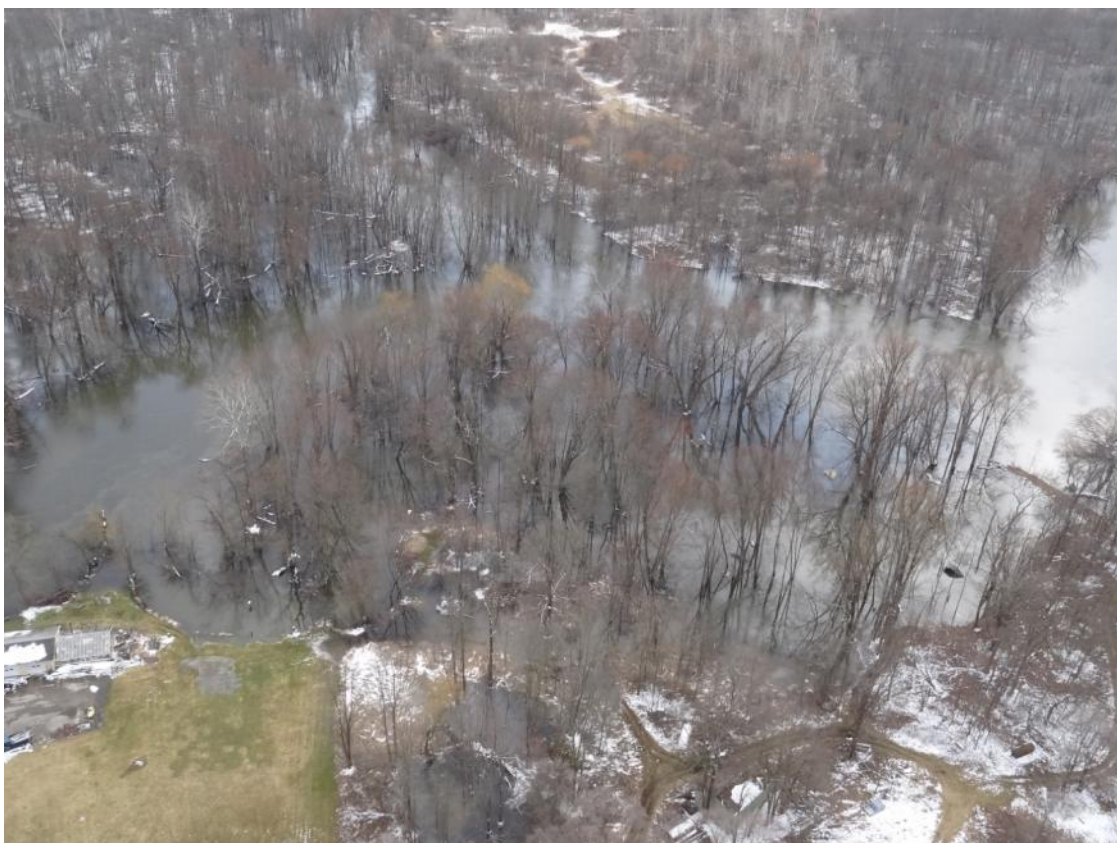
42. Observed flooding at MP26.0

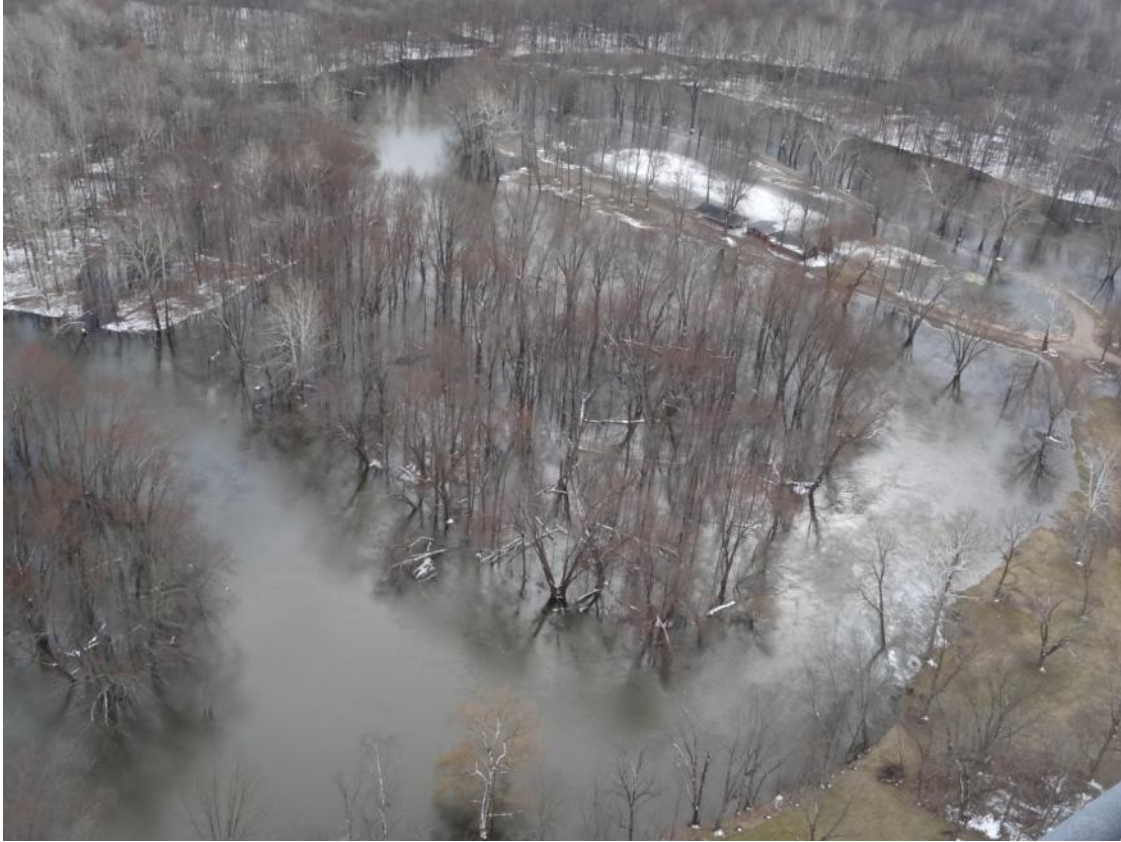
43. Observed flooding at MP27.0 Shady Bend Campground.
